SCHEMATIC PLAN

Si View Park Trail Connection, North Bend, Washington

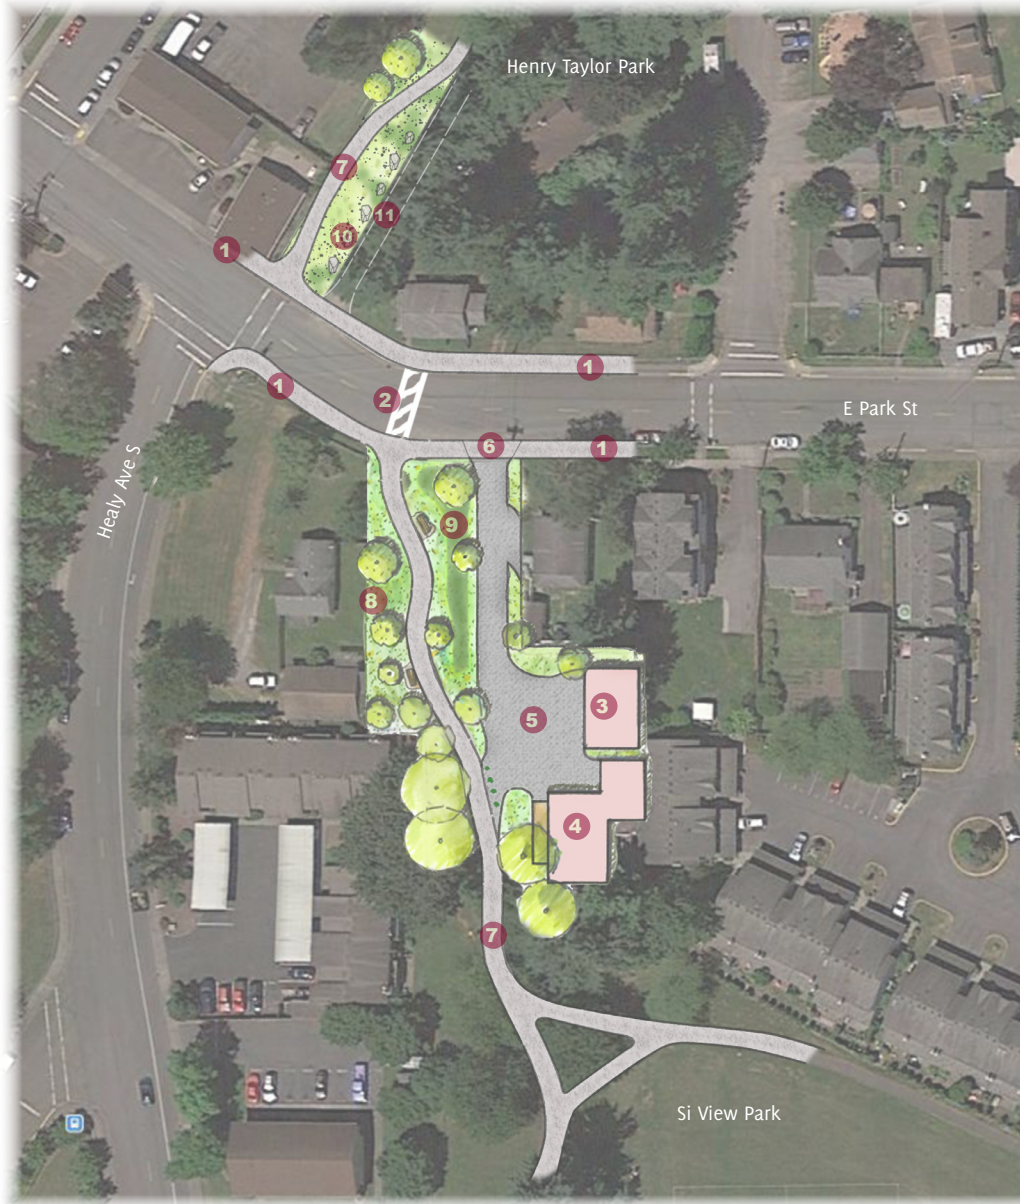
- 1 Connection to existing sidewalk
- 2 Mid-block pedestrian crossing with flashing light
- 3 Future Maintenance Building
- 4 North Maintenance Annex
- 5 Maintenance parking lot
- 6 Vehicle turnout
- 7 Connection to existing trail
- 8 Vegetative screening
- 9 Rain garden with interpretive sign
- 10 Landscape boulders
- 11 Existing driveway to remain
